ADDENDUM NO. 1

RFP #25-100

CSAC Building Renovation & Expansion

**HAZARDOUS MATERIALS SURVEY
FINAL REPORT**

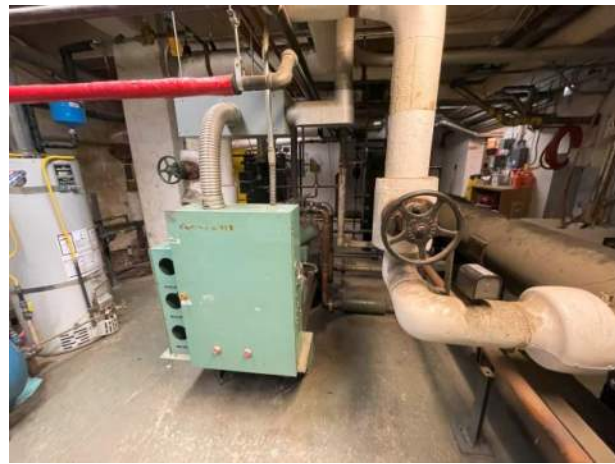
View white pipe wrap

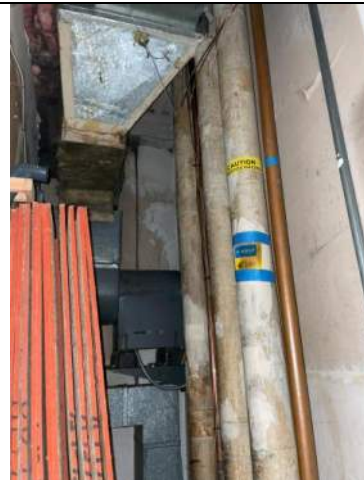
View of asbestos warning on insulation pipe

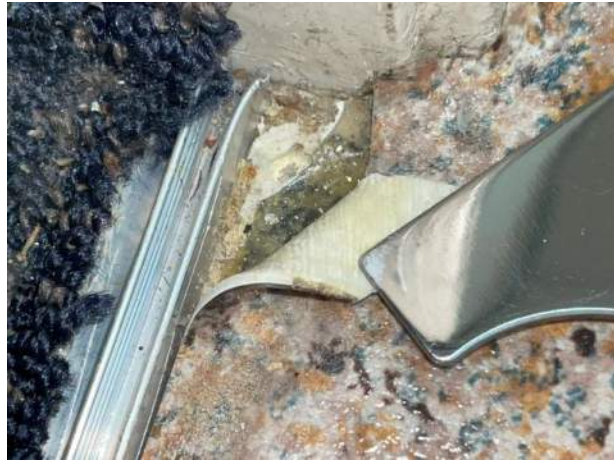
View of layers under multicolor vinyl sheet flooring

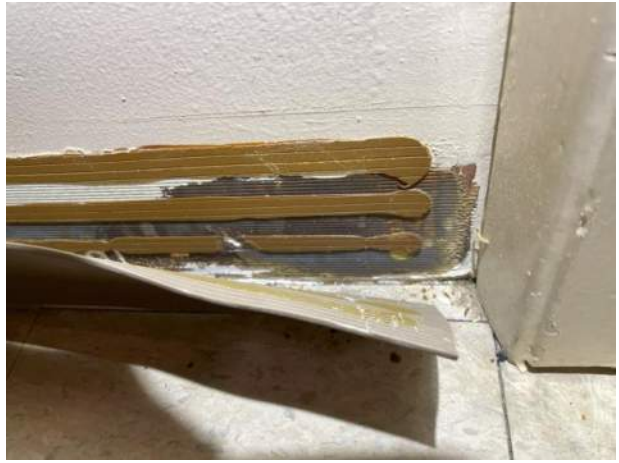
View of mastic under 4" brown base cove

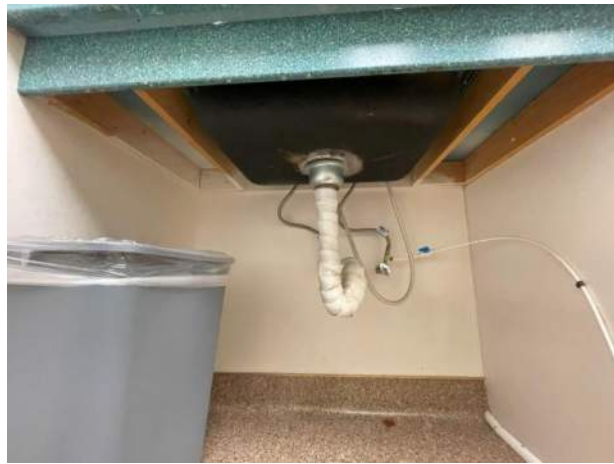
View of black sink undercoat

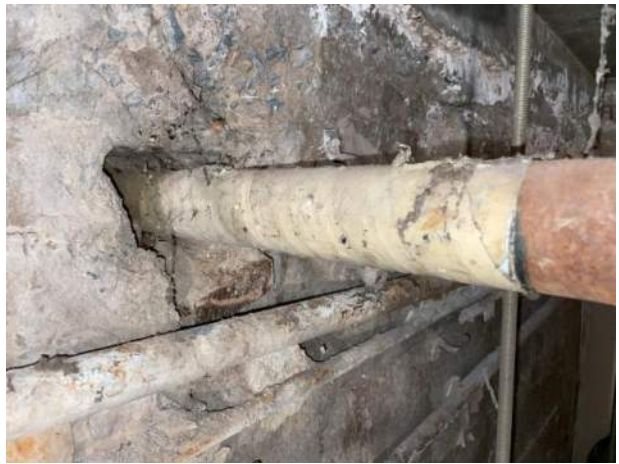
View of white tape on pipe- basement

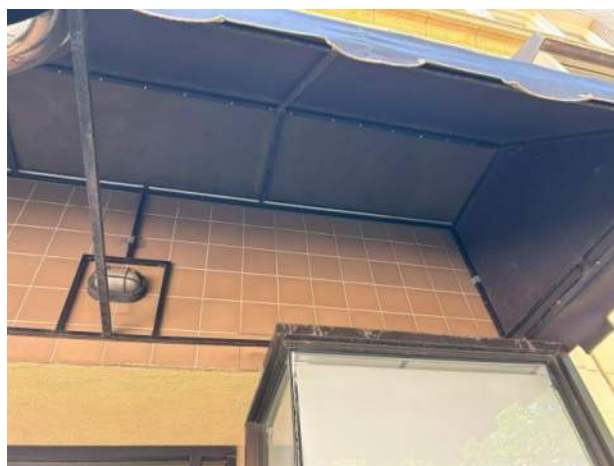
View of exterior 9" x 9" ceramic wall tile

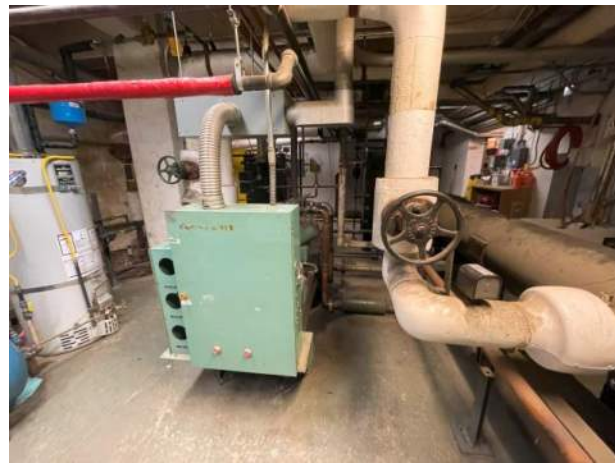
View white pipe wrap

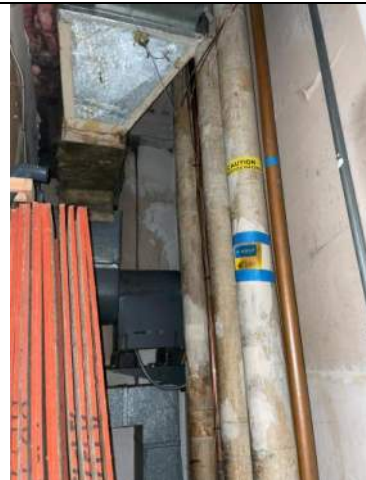
View of asbestos warning on insulation pipe

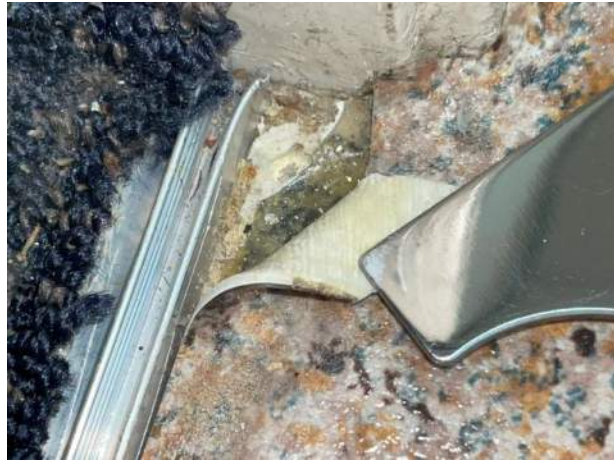
View of layers under multicolor vinyl sheet flooring

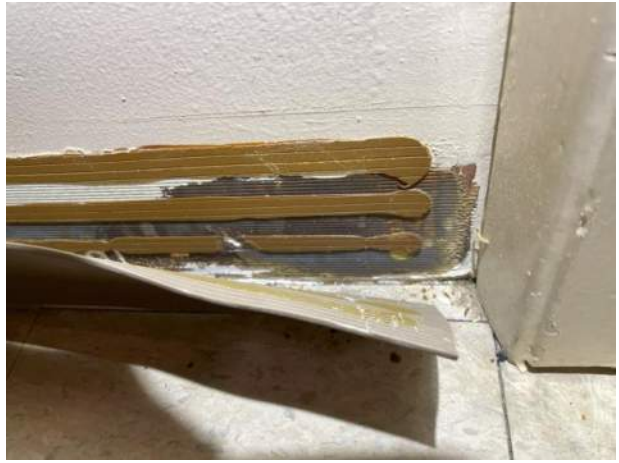
View of mastic under 4" brown base cove

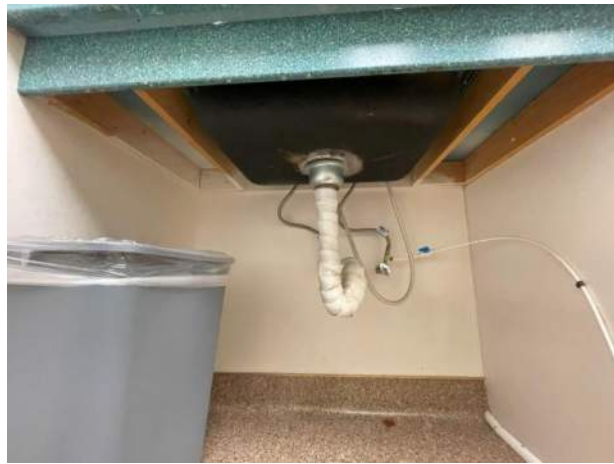
View of black sink undercoat

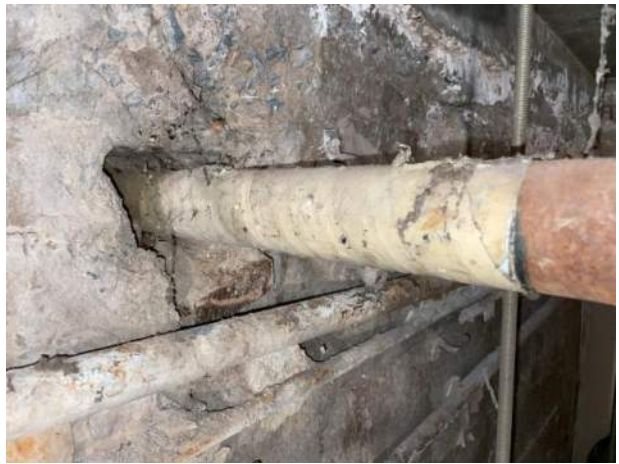
View of white tape on pipe- basement

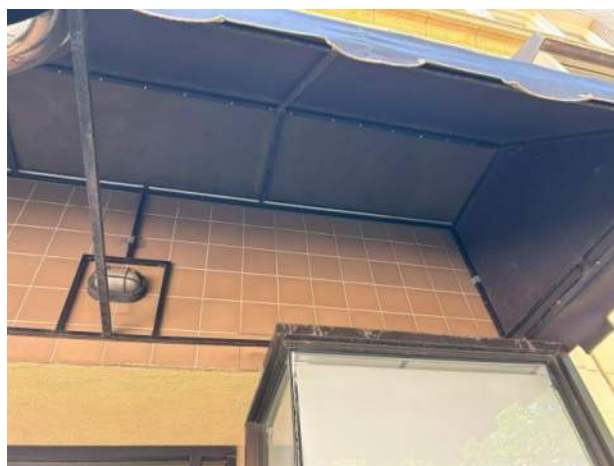
View of exterior 9" x 9" ceramic wall tile
