ADDENDUM NO. 1

RFP #25-100

CSAC Building Renovation & Expansion

**HAZARDOUS MATERIALS SURVEY
FINAL REPORT**

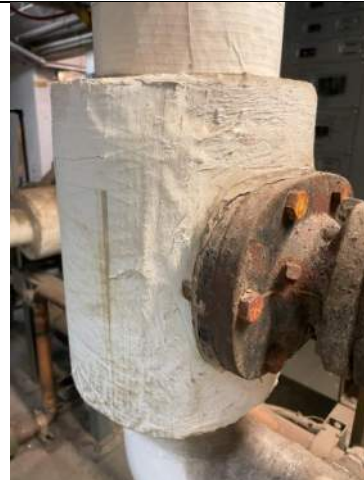
View of white pipe wrap

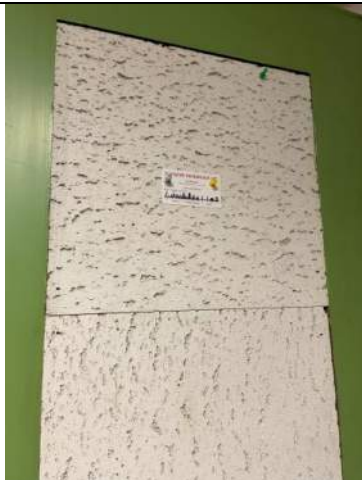
View of ceiling tile with fissure pattern over door

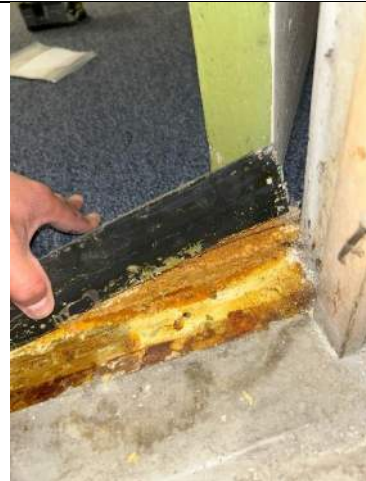
View of layers under blue rolled carpet-basement

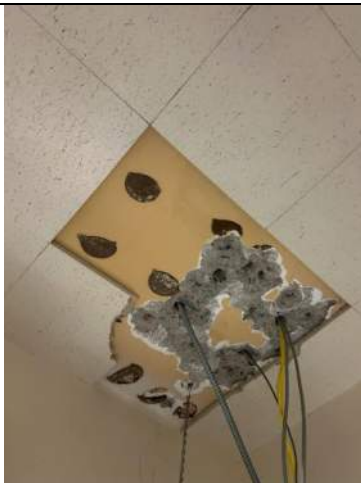
View of mastic pucks under 12" x 12" ceiling tile

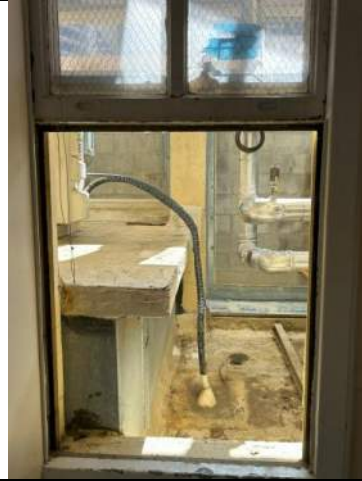
View of exterior mechanical room

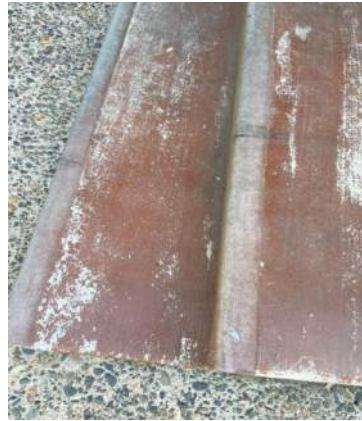
View of exterior burgundy stair system
